Appendix I4

Biological Opinion & Biological Assessment

Consultation Number: 02ETAU00-2015-F-0031

RE: CSJs 0253-04-138 & 0253-04-146

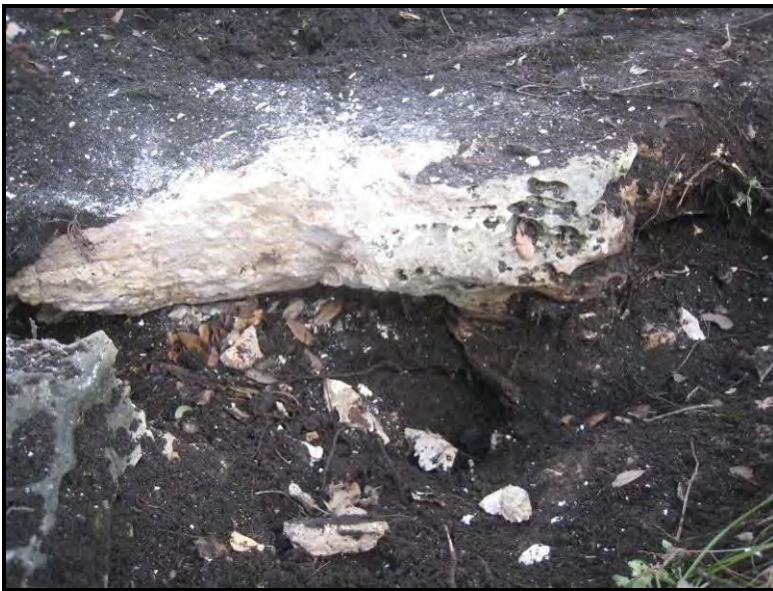
281-042, non-karst closed depression/animal burrow This feature is located on private property on the west side of US 281. When initially assessed, it consisted of two depressions within an area measuring 1 by 2 m (3.3 by 6.6 ft) (Figure 69). It had infill of leaf litter and modern soil that was loose to a depth of 15 cm (0.5 ft). Excavation was conducted on 10 September 2010. This effort utilized 1 person-hour of effort and removed 0.1 m³ (3.5 ft³) of material. Post-excavation dimensions of the largest feature were 0.75 m (2.5 ft) in diameter and 0.3 m (1 ft) deep. This feature is an old, filled animal burrow that goes under a slab of limestone and exits the other side (Figure 70). It is not a karst feature.

Figure 70. Feature 281-042 after excavation.

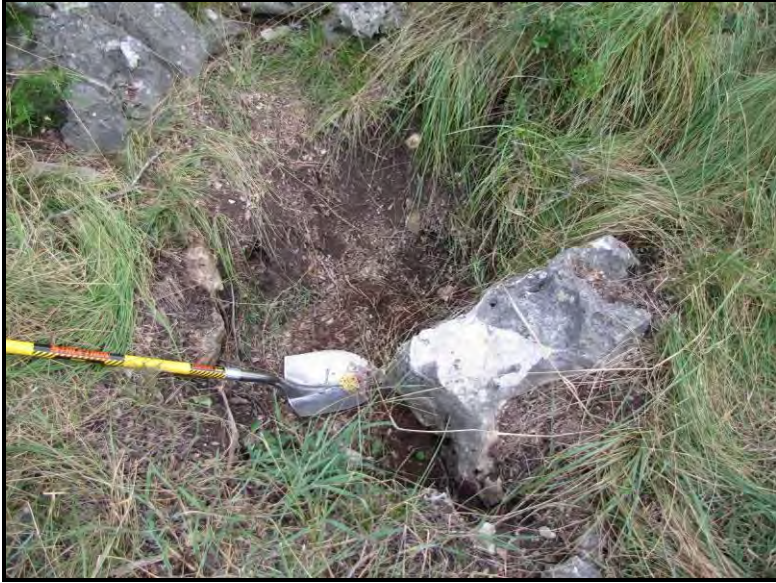
Figure 71. Feature 281-043 prior to excavation.

281-043, non-karst closed depression/animal burrow This depression was 2 m (6.6 ft) in diameter and 1 m (3.3 ft) deep when initially assessed (Figure 71). It had fine infill of leaf litter and black, modern soil. Excavation was conducted on 3 August 2010; 1 m³ (35 ft³) of dirt and leaves was removed from the feature. Post-excavation dimensions of the feature were 2 m (6.6 ft) long by 2.5 m (8.2 ft) wide by 1 m (3.3 ft) deep. The floor was hard-packed red clay, with an animal burrow at the south end of the feature (Figure 72). Construction activities on this ROE site later resulted in the area being graded over.

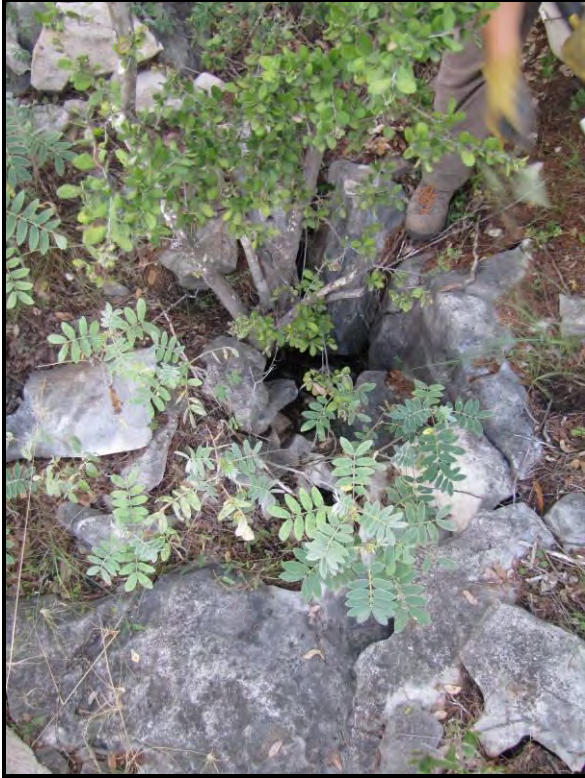
281-044, solutional sinkhole When initially assessed, this solutional sinkhole was 2.5 m (8.2 ft) long, 1.25 m (4.1 ft) wide, and 1.2 m (3.9 ft) deep (Figure 73). It contained infill composed of leaf litter and modern, black soil that was loose to a depth of 20 cm. It is recharged by sheet-wash from an area measuring 30 by 30 m (98 by 98 ft). Excavation on 3 August 2010 removed 2.5 m³ (88 ft³) of loose soil and rocks, deepening the feature to 1.8 m (5.9 ft) (Figure 74). Post-excavation dimensions of this feature were 2.5 m (8.2 ft) long, 1.25 m (4.1 ft) wide, and 1.8 m (5.9 ft) deep. At that point ROE for excavation was revoked, preventing further excavation that would likely have led to a cave. The feature was backfilled.

Figure 73. Feature 281-044 prior to excavation.

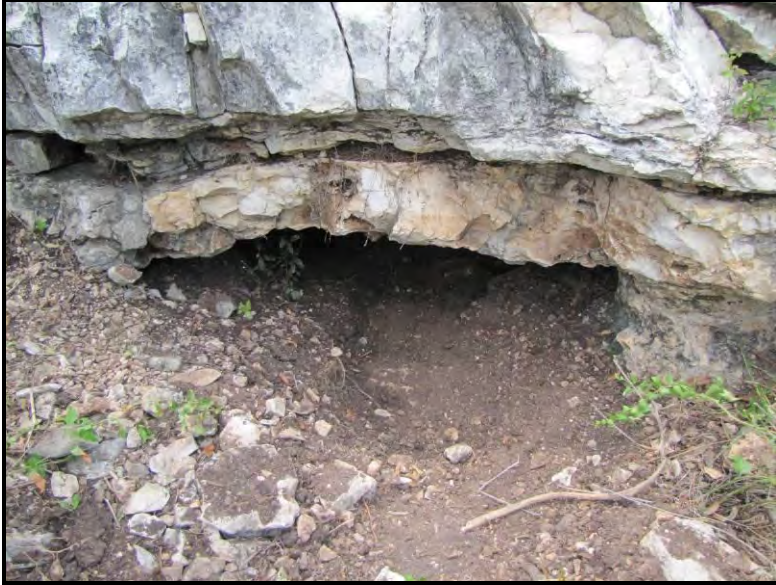
Figure 75. Entrance to the western portion of feature 281-045.

281-045, cave This feature is located in drainage, and consists of two low, enlarged bedding planes that cut back under the drainage (Figure 75 and Figure 77). Flood waters cascading down over the top of these entrances has caused scour, piling up gravel and rocks just downstream. The westernmost of the two entrances extends in for 3 m (9.8 ft) to a bedrock terminus (Figure 76). The eastern entrance extends 4 m (13.1 ft) and also terminates in bedrock (Figure 78). Excavation was conducted on 4, 19, and 25 August to enlarge these bedding plane openings for biological evaluation. Using hand and power tools, 2 m³ (71 ft³) of material was removed with 25.5 person hours of effort. The cave was mapped during a subsequent visit (Figure 79). Post-excavation dimensions of this feature were 7 m (23 ft) long, 4 m (13.1 ft) wide and 0.7 m (2.3 ft) deep.

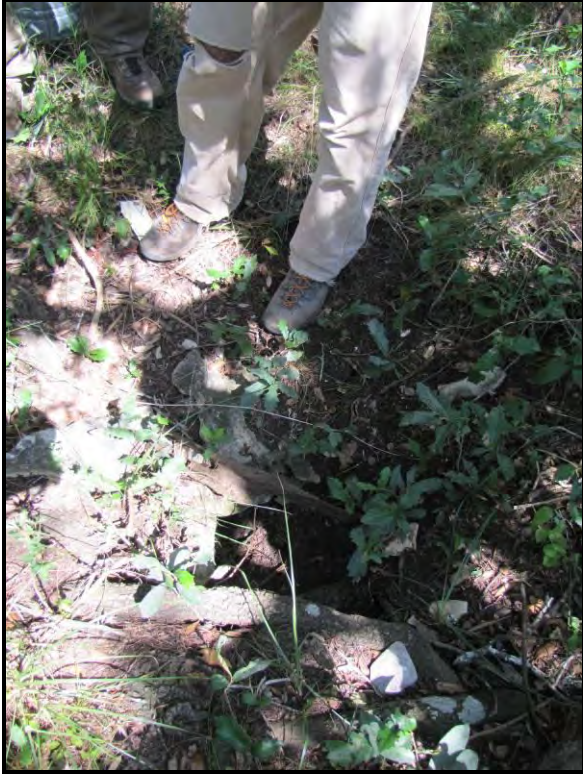
Figure 80. Feature 281-046 prior to excavation.

281-046, non-karst closed depression/animal burrow When initially assessed, this feature was a depression 0.3 m (1 ft) in diameter containing roots and water (Figure 80). It had infill of leaf litter and modern, black soil. Excavation conducted on 4 August 2010 removed some soil, and revealed an animal burrow. Post-excavation dimensions of the feature were 1 m (3.3 ft) in diameter by 0.5 m (1.6 ft) deep (Figure 81). It is not a karst feature.

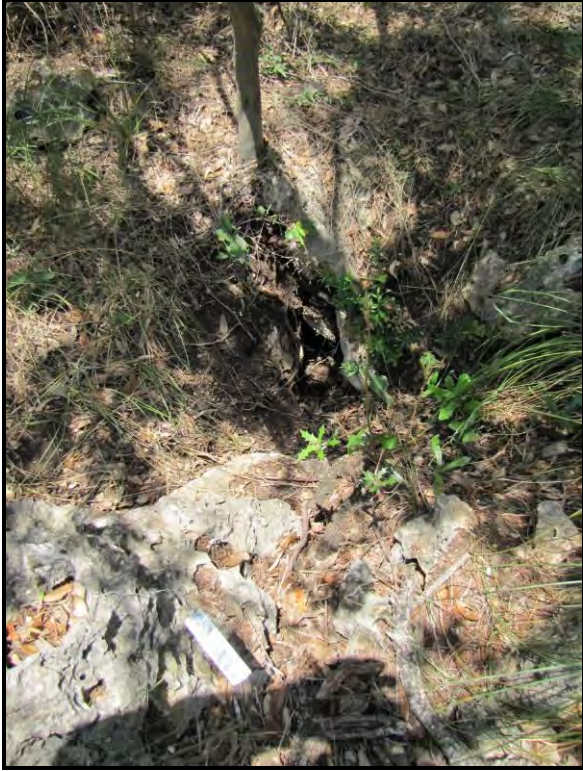
Figure 82. Feature 281-047 prior to excavation.

281-047, solutional sinkhole When initially assessed, this feature was 1.5 m (4.9 ft) long, 1 m (3.3 ft) wide, and 0.4 m (1.3 ft) deep (Figure 82). It contained fine black sediment of modern soil and leaf litter. It was excavated on 3 August 2010 to a solid bedrock floor (Figure 83).

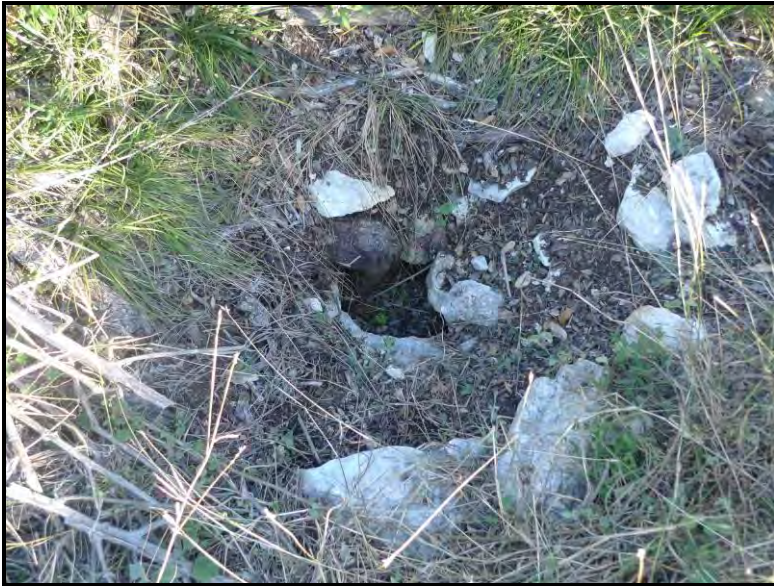
Figure 84. Overview of feature 281-048.

281-048, solutional sinkhole This solutional sinkhole was 3 m (9.8 ft) long and 1 m (3.3 ft) wide and 2 m (6.6 ft) deep (Figure 84) and contained fine infill of black, modern soil and

leaf litter (Figure 85). Airflow was detected in the feature on 12 March 2010. It was recommended for excavation, but ROE for excavation purposes was denied.

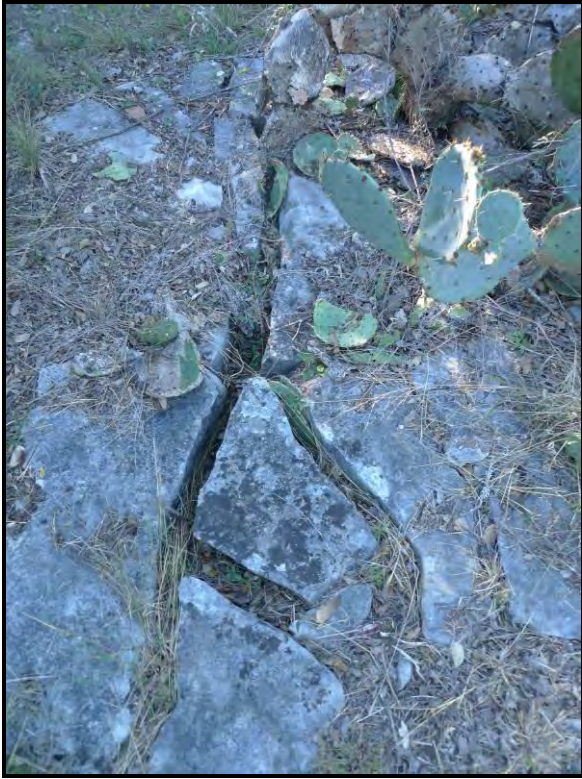
Figure 86. Overview of feature 281-051.

281-051, enlarged fractures This is a set of enlarged cross-fractures located on private property. The feature was 2.5 m (8.2 ft) long, 0.2 m (0.7 ft) wide, and 0.3 m (1 ft) deep. The main fracture trends at approximately 90 degrees, with several minor fractures crossing at 45 degrees (Figure 86). It receives sheet-wash drainage from an area measuring 20 by

30 m (66 by 98 ft). It has infill of black, modern soil and leaf litter that is loose to a depth of 0.3 m (1 ft). It was recommended for excavation, but ROE for excavation purposes was not obtained.

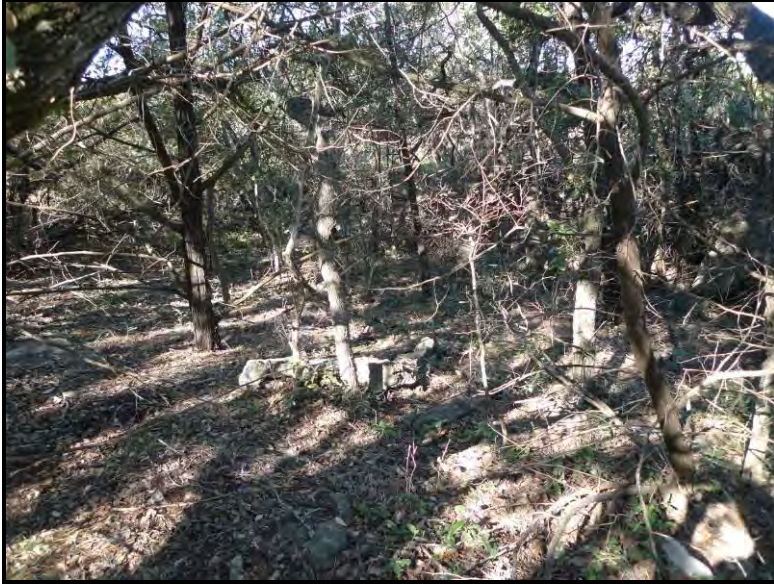
281-052, non-karst closed depression This feature is located on the west side of US 281 on private property. It is a 10 m-diameter (32.8 ft) depression with a depth of 1.5 m (4.9 ft) (Figure 87) formed by the introduction of landfill material on its north side and not by karst processes. This feature was not recommended for excavation (Table 1).

Figure 87. Overview of feature 281-052.

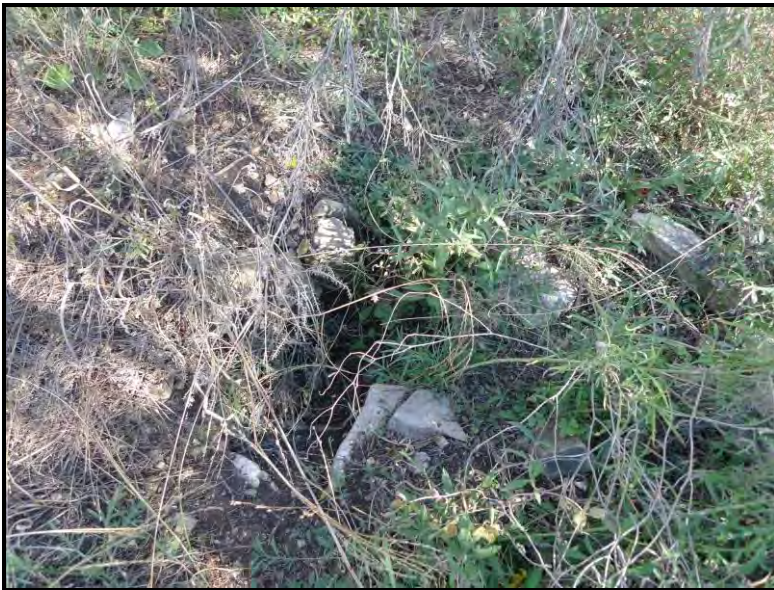
281-053, non-karst closed depression It is located on the west side of US 281 on private property. It is composed of three openings within an area that is 3 m (9.8 ft) long, 0.6 m (2 ft) wide, and 1 m (3.3 ft) deep (Figure 88). This feature is located in the same landfill deposit as feature 281-052. It was recommended for excavation, but when excavation commenced on 10 September 2010, it was immediately determined to be non-karstic. It is formed in a landfill deposit, and is a result of collapse or piping into loose fill.

Figure 88. Overview of feature 281-053.

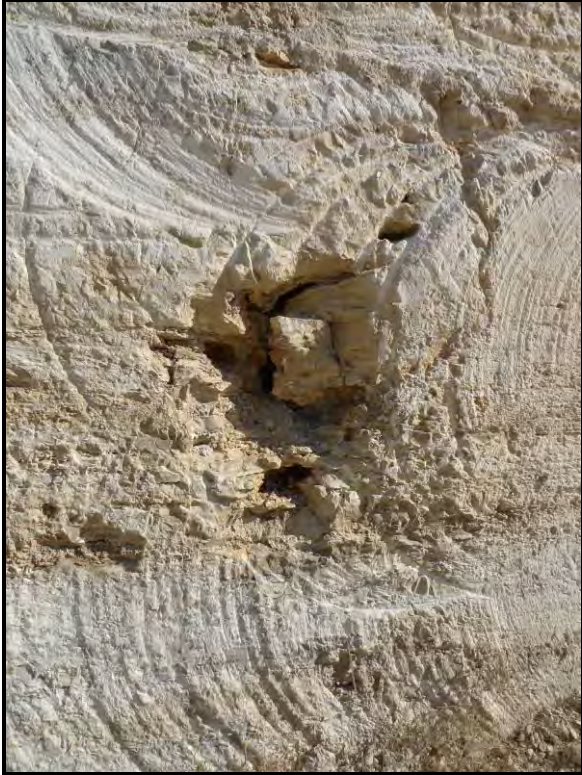
Figure 89. Overview of feature 281-054.

281-054, solution cavity/enlarged bedding plane This feature is an enlarged bedding plane at the base of a road cut on private property on the east side of US 281 (Figure 89). This opening is 8 m (26.2 ft) wide, 0.3 m (1 ft) tall, and extends at least 0.6 m (2 ft) into the cut (Figure 90).

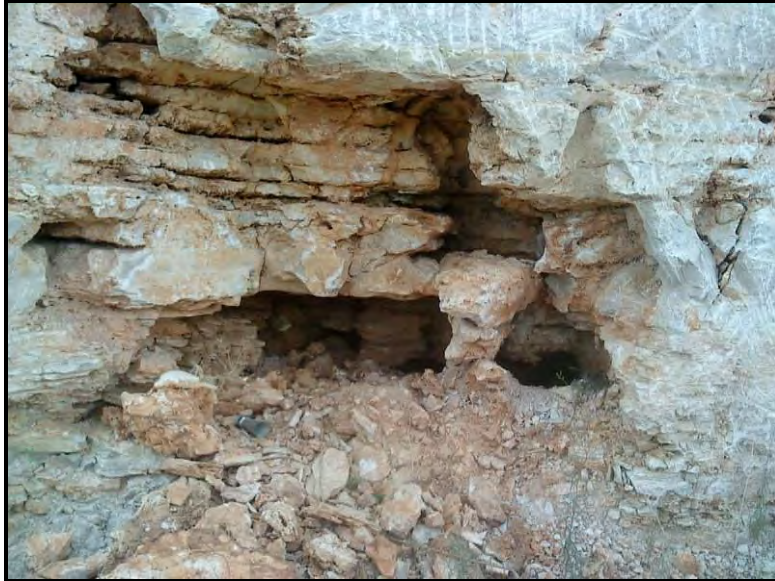
Figure 91. Overview of feature 281-055.

281-055, solution cavity/enlarged bedding plane This feature is an enlarged bedding plane at the base of a construction site road cut on private property. It is 2 m (6.6 ft) wide, 1.7 m (5.6 ft) tall, and extends into the road cut for 1 m (3.3 ft) (Figure 91). It is developed along a fracture bearing 90 degrees. It was recommended for excavation, but ROE for excavation purposes was not granted.

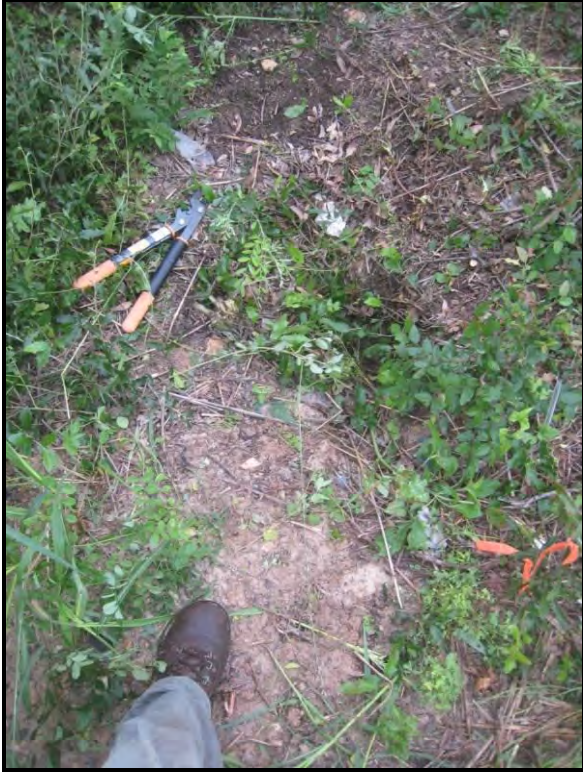
Figure 92. Feature 281-056 prior to excavation.

281-056, non-karst closed depression/animal burrow This feature is located on the east side of 281, in the north flood plain of Mud Creek. When initially assessed, it was a depression in soil 1 m (3.3 ft) in diameter and 0.5 m (1.6 ft) deep (Figure 92). Excavation was conducted at this feature on 20 May 2010 by two persons for 50 minutes. Approximately 0.05 m³ (1.8 ft³) of fill was removed from the feature to reveal an animal burrow (Figure 93). Post-excavation dimensions of this feature were 1 m (3.3 ft) in diameter by 0.75 m (2.5 ft) deep. The only fauna encountered in this feature were a surface centipede in the order Scutigermorpha (family Scutigerae) and a rattlesnake (*Crotalus atrox*).

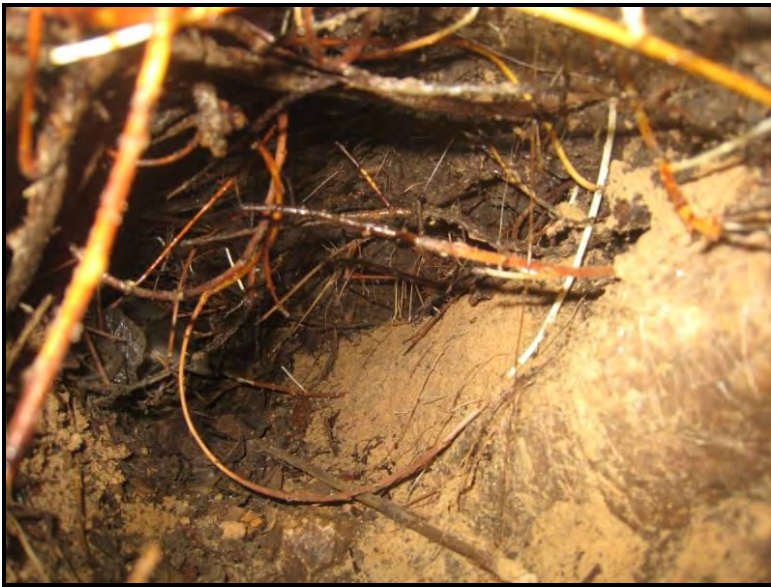
Figure 93. Feature 281-056 after excavation. It is an animal burrow.

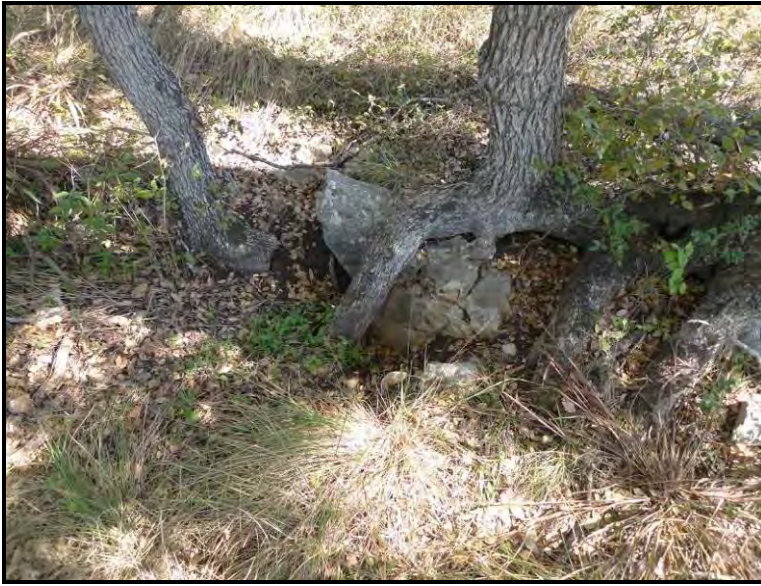
Figure 94. Overview of feature 281-057.

281-057, solutional sinkhole This feature consisted of a depression that was 1.5 m (4.9 ft) in diameter and 0.4 m (1.3 ft) deep (Figure 94). It had a large rock on its south side, and was filled with fine black sediment and leaf litter that was loose to a depth of 0.3 m (1 ft). There was a small tree with some exposed growing from the feature. The feature receives sheet wash flow from an area measuring 25 by 30 m (82 by 98 ft). It was recommended for excavation; however ROE was rescinded prior to the initiation of excavation activities.

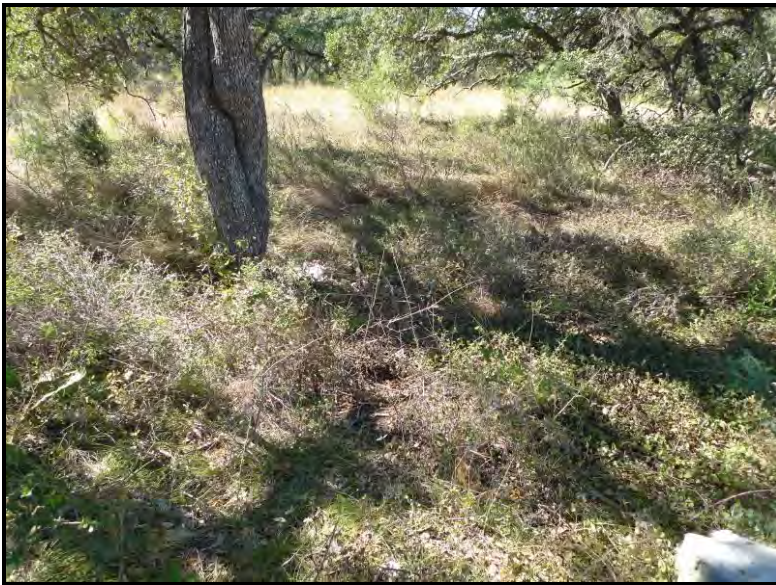
281-058, sinkhole This is potentially a collapse or solutional sinkhole that is 3.5 m (11.5 ft) in diameter and 0.7 m (2.3 ft) deep. It is filled with soil and has two live oak trees growing out of it (Figure 95). It was recommended for excavation in order to determine its origin; however, ROE was rescinded prior to the initiation of excavation activities.

Figure 95. Overview of feature 281-058.

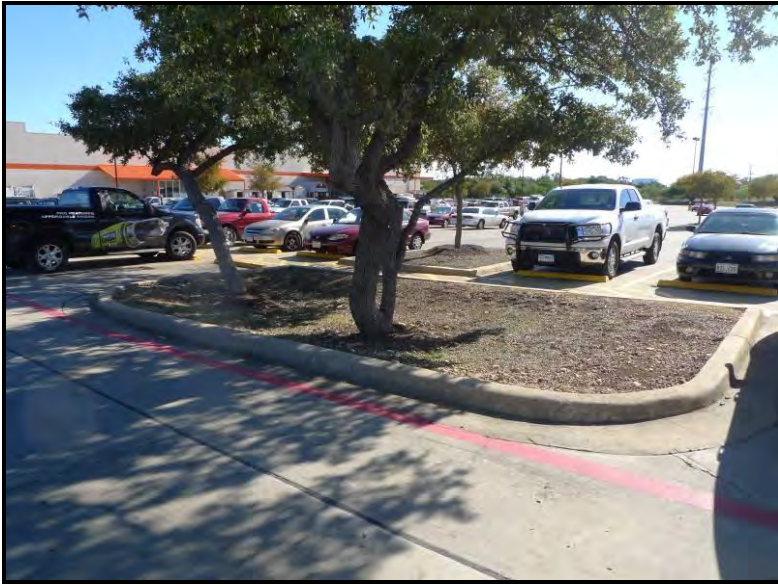
281-059, non-karst closed depression This depression is 5 m (16.4 ft) long, 3 m (9.8 ft) wide and 0.5 m (1.6 ft), and is surrounded by a curbed parking lot. There are two oak trees within it (Figure 96). It was most likely formed by the area surrounding it being built up for the parking lot, with the area around the trees left unfilled so that the trees would not die. It is a non-karst closed depression. This feature was not recommended for excavation (Table 1).

Figure 96. Overview of feature 281-059.

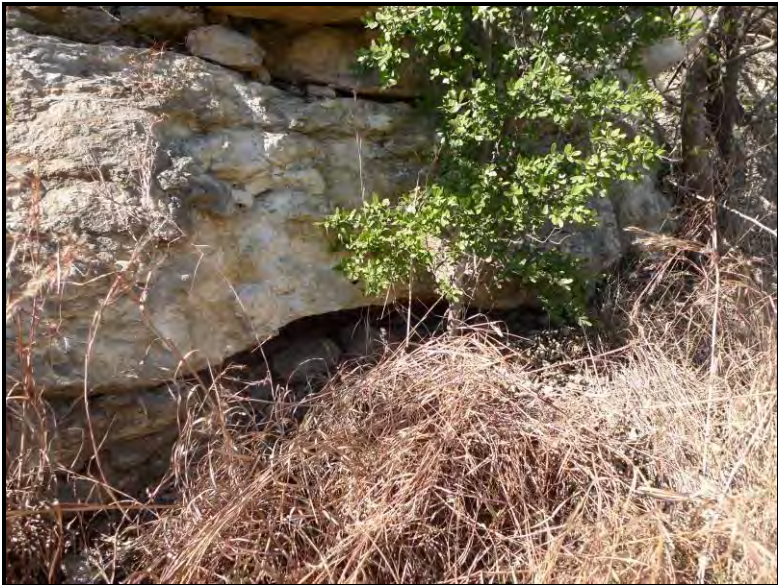
281-060, solution cavity/enlarged bedding plane This is an enlarged bedding plane opening in a road cut on the west side of US 281. It consists of three side by side openings within an area 2.25 m (7.4 ft) wide (Figure 97). They are 0.3 m (1 ft) tall and extend no more than 0.5 m (1.6 ft) into the road cut (Figure 98). This feature was not recommended for excavation (Table 1).

Figure 97. Overview of feature 281-060.

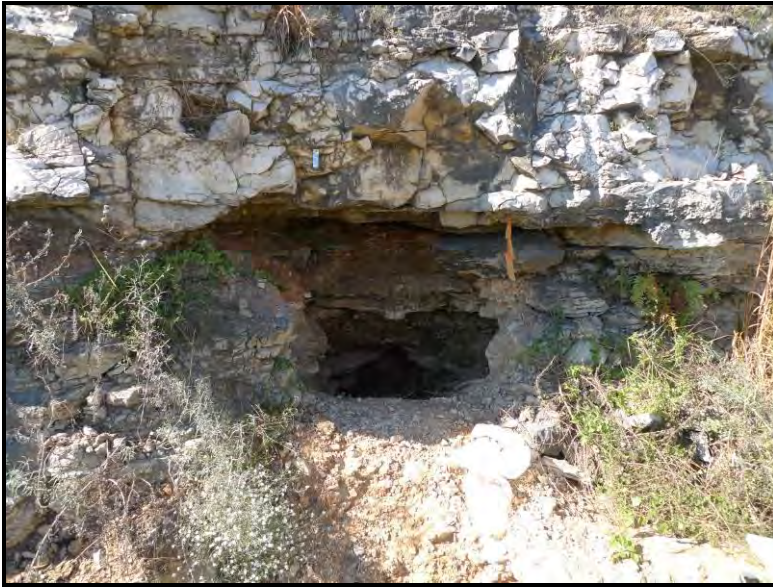
Figure 99. Overview of feature 281-062.

281-062, cave This enlarged bedding plane in the road cut on the west side of US 281 had a 1.9 m wide and 0.75 m high entrance (Figure 99), and extended 2 m (6.6 ft) into the road cut. Excavation was conducted on 3 June 2010, when 3 m³ of material was removed. These rocks were lightly cemented together with calcite, with voids between them. The excavation trended back underneath the roadway with an unstable ceiling, and excavation efforts ceased about 5 m into the feature (Figure 99). Post-excavation dimensions of the cave were 5.4 m long (17.7 ft) by 1.5 m (4.9 ft) wide and 3.4 m (11.1 ft) deep (Figure 101).

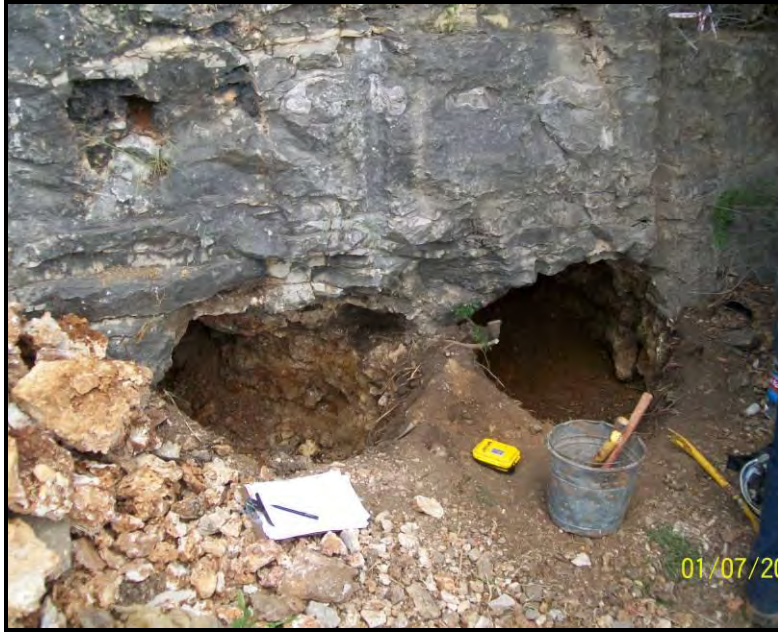
Figure 102. Entrances to feature 281-063.

281-063, cave This feature is in the road cut on the west side of US 281, south of Encino Rio. It has two entrances at the base of the road cut that were initially 0.5 m (1.6 ft) wide (Figure 102). The northern entrance could be seen to extend 2 m into the road cut and continued on. It contained infill of leaf litter and modern soils. It was excavated on 3, 14, and 23 June 2010 (Figure 103). These excavations resulted in the removal of 3 m³ (106 ft³) of material from the feature. The resulting cave is 7 m (23 ft) long; with a small connection between the two entrances that is not passable (Figure 101). Each entrance is 1 m (3.3 ft) wide and both passages drop below the level of the roadway shoulder to a depth of 1.4 m (4.6 ft). The south entrance quickly rejoins the main passage in the north section. The cave ends in a flowstone wall. Biological surveys on this feature were conducted on 25 June, and 1, 9, 12, and 24 September 2010. A complete list of fauna encountered in 281-063 is included in Table 15 and microclimate measurements are included as Table 16.

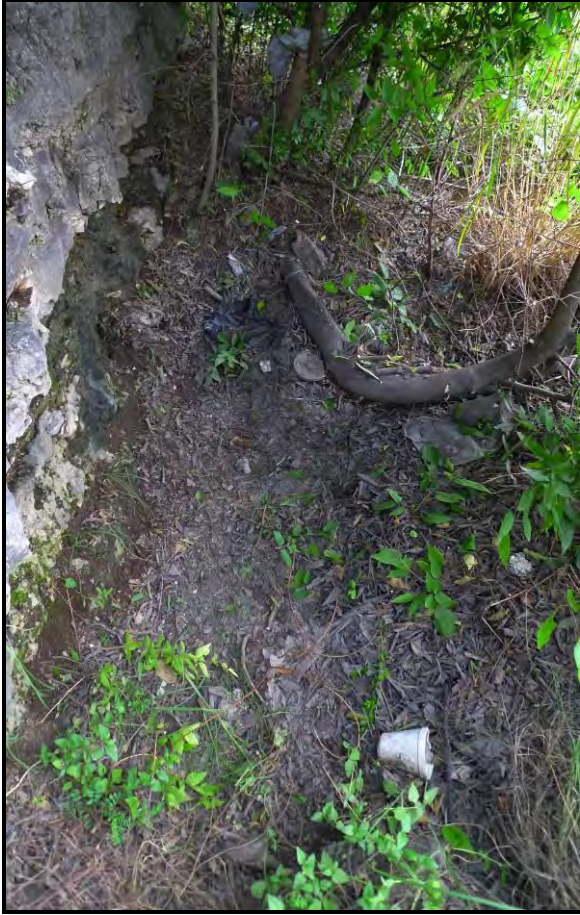
Figure 104. Feature 281-064 prior to excavation.

281-064, non karst closed depression This is a depression at the base of the road cut on the west side of US 281. When initially assessed it was 2 m (6.5 ft) in diameter and 0.3 m (1 ft) deep (Figure 104). It had fine infill of leaf litter and modern soils. It receives sheetwash from a drainage area of 600 m² (6,458 ft²) from the bar ditch. It was excavated on 14 June 2010; 0.05 m³ (1.8 ft³) of material was removed with 2 person hours of labor. Post-excavation dimensions of the feature were 2 m (6.5 ft) in diameter and 1.25 m (4.1 ft) deep. Excavation reached a bedrock bottom with an apparent drain hole. However, this hole is actually a drill hole from the original road cut construction (Figure 105), not part of a karst feature.

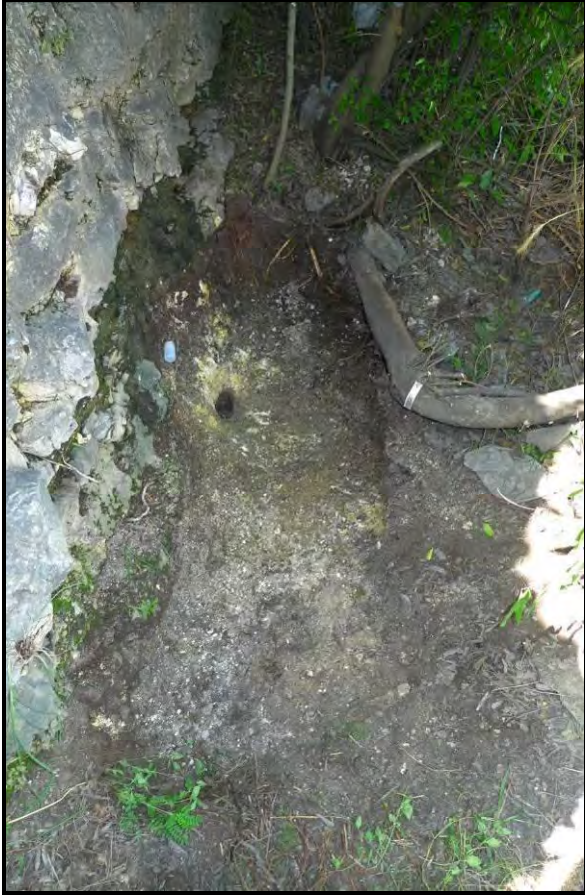
Figure 105. Feature 281-064 after excavation, with drill hole visible.

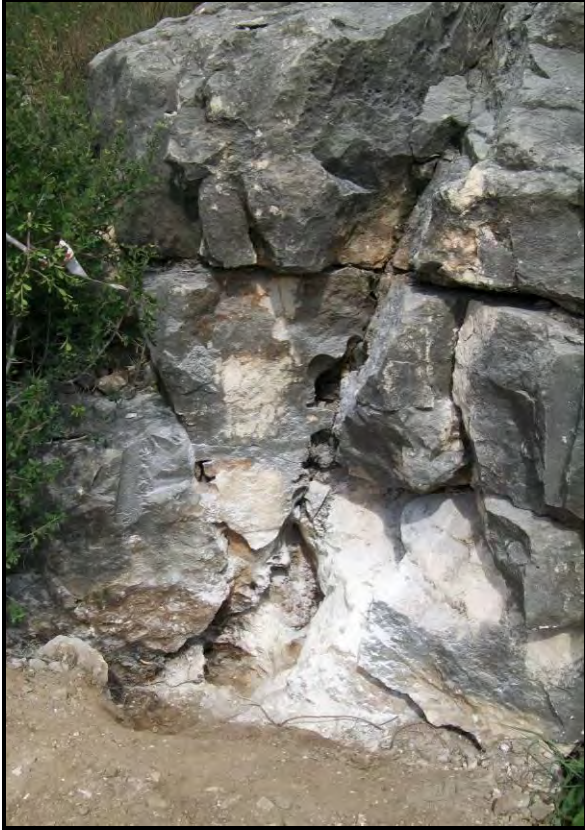
281-065, enlarged fracture This is an enlarged fracture in the road cut on the west side of US 281 that had an opening 0.5 m (1.6 ft) wide and 1 m (3.3 ft) high (Figure 106). It dropped downward at least 0.5 m (1.6 ft). It was excavated on 17, 21, and 23 June 2010 for 17 person hours, removing 1.25 m³ (44 ft³) of hard rock with jackhammers. After to a depth of 1 m (3.3 ft), no voids could be seen extending from the feature (Figure 107). Post-excavation dimensions of the feature were 1 m (3.3 ft) in length by 1 m (3.3 ft) in width by 1 m (3.3 ft) in depth.

Figure 106. Feature 281-065 during excavation, showing solutionally-enlarged fracture.

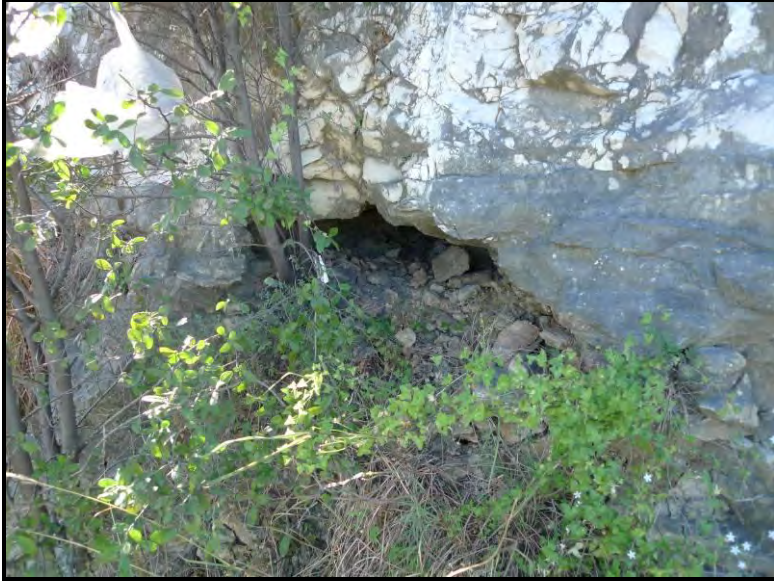
Figure 108. Overview of feature 281-066.

281-066, enlarged fracture This feature is located in the road cut on the west side of US 281. It is an enlarged fracture/bedding plane trending at 90 degrees that is 0.5 m (1.6 ft) wide, 0.25 m (0.8 ft) tall (Figure 108), and it extends into the road cut for 1.25 m (4.1 ft) (Figure 109). This feature was not recommended for excavation (Table 1).

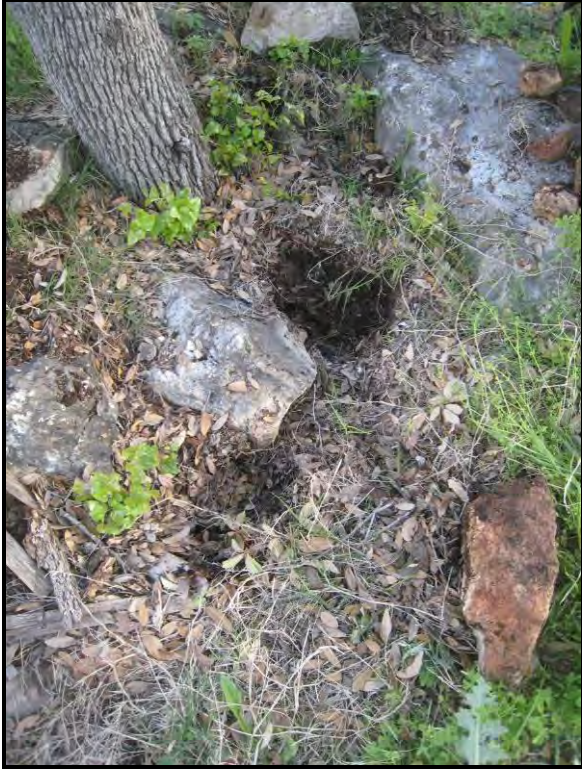
Figure 110. Overview of feature 281-067.

281-067, collapse sinkhole This feature appears to be a collapse sinkhole (Figure 110). It is 1 m (3.3 ft) in diameter and 0.3 m (1 ft) deep, with infill composed of black, modern soil, leaf litter, and rocks. It was recommended for excavation, but ROE for that purpose was denied.

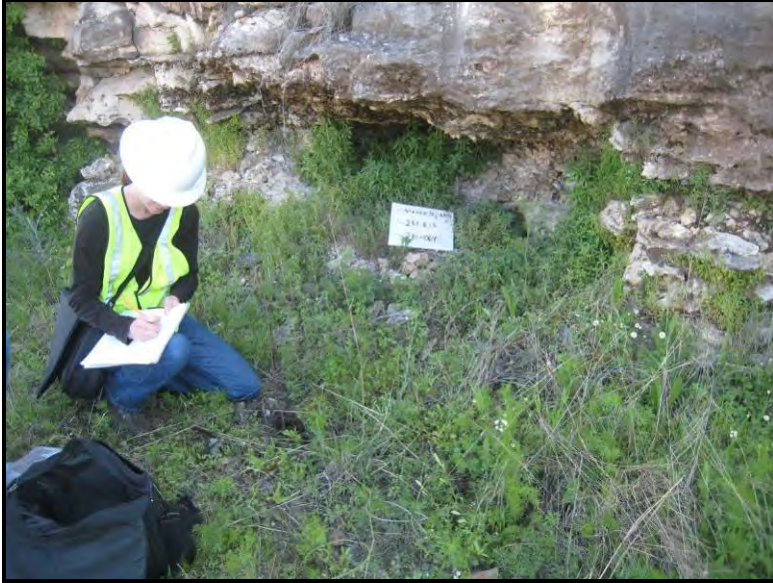
Figure 111. Overview of feature 281-069.

281-069, solution cavity/enlarged bedding plane This enlarged bedding plane is located in the road cut on the east side of US 281 (Figure 111). It is 1.5 m (4.9 ft) wide, 0.5 m (1.6 ft) tall, and extends into the road cut for 1.5 m (4.9 ft). It has a coarse infill of rocks (Figure 112). This feature was not recommended for excavation (Table 1).

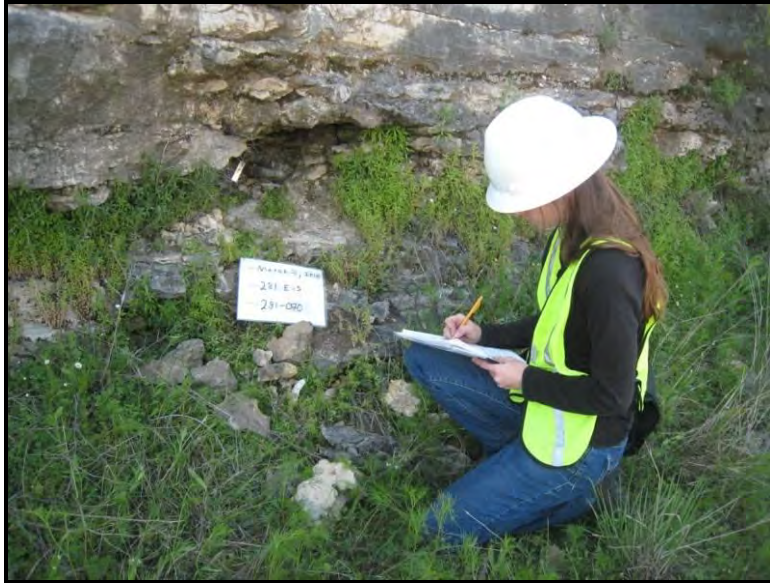
Figure 113. Overview of feature 281-070.

281-070, Stafford Cave This feature is located in the east road cut of US 281. It is an enlarged bedding plane that had an entrance 0.4 m (1.3 ft) in diameter (Figure 113), and it could be seen to extend 1.5 m (4.9 ft) into the road cut with a small opening continuing on. Slight airflow was detected. It was excavated on 16-17 June 2010. Fourteen person-hours of effort were utilized to remove rocks in order to make the crawlway passable (Figure 114). The cave can be entered for 9 m (29.5 ft) before it becomes too low to pass (Figure 115). The post-excavation width was 2 m (6.6 ft) and the depth was 1 m (3.3 ft). The cave was named for the brand of an article of clothing found in the entrance. A map of the cave and other nearby features is presented in Figure 116. Biological surveys on this feature were conducted on 18 and 25 June, and 1, 9, and 16 September 2010. A complete list of fauna encountered in 281-070 is included in Table 17 and microclimate measurements are included as Table 18. Stafford Cave is developed in the same bedding plane as numerous

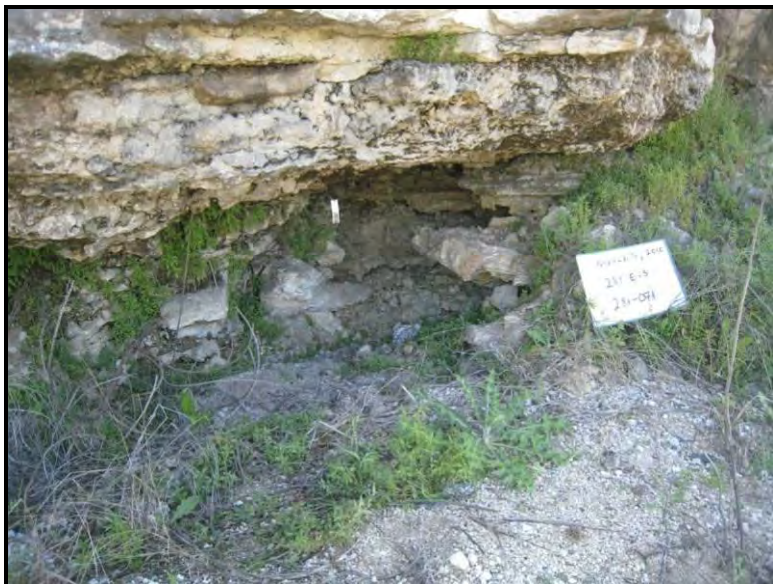
Figure 118. Overview of feature 281-071.

281-071, solution cavity/enlarged bedding plane This feature is located in the east road cut of US 281. It is an enlarged bedding plane with an entrance that is 2 m (6.6 ft) wide and 1 m (3.3 ft) high (Figure 118). It extended for 3 m (9.8 ft) into the road cut, with a small hole continuing on (Figure 119). Previous excavation has occurred here, as evidenced by a tailings pile just outside of the entrance. It was excavated on 16 June 2010. About 1 m³ (35 ft³) of rock was removed from the back of the feature, which was a bedding plane shelf with small openings continuing on (Figure 120). Further excavation effort would have required intense bedrock mining. Given that it was developed in the same bedding plane as the sample-able habitat in Stafford Cave and Cool Cave on either side of it, further excavation efforts were not deemed worthwhile. The post-excavation dimension were 3 m (9.8 ft) long by 2 m (6.6 ft) wide bay 1.3 m (4.3 ft) deep. One troglobite (*Brackenridgia* sp.) was encountered during excavation, so presence/absence surveys were performed.

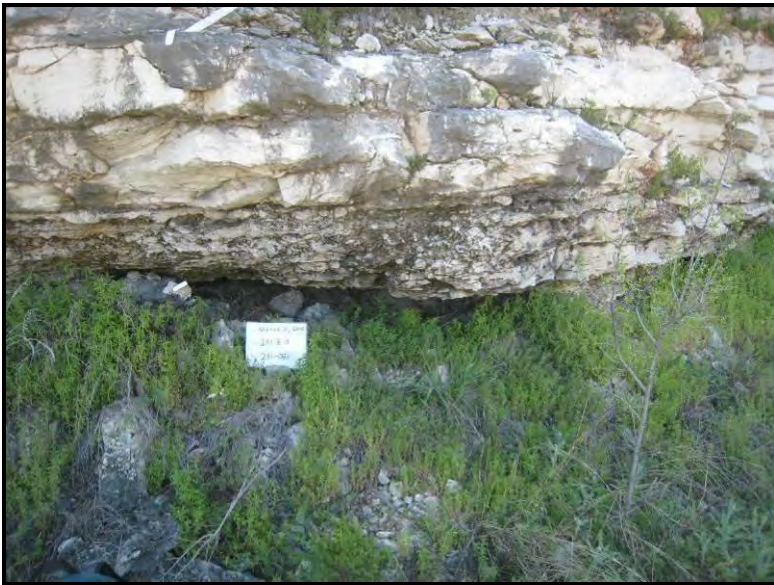
281-072, solution cavity/enlarged bedding plane This is an enlarged bedding plane opening that is 2.5 m (8.2 ft) wide, 0.4 m (1.3 ft) tall, and extends 1.5 m (4.9 ft) into the road cut (Figure 121). Tiny mesocavernous voids extend off of it in the same bedding plane as surrounding caves and features (Figure 122). This feature was not recommended for excavation (Table 1).

Figure 121. Overview of feature 281-072.

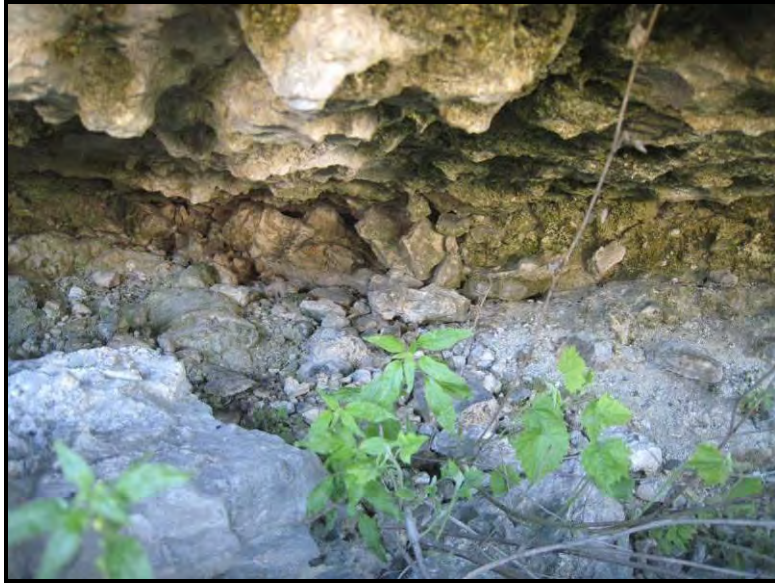
Figure 122. Interior of feature 281-072.

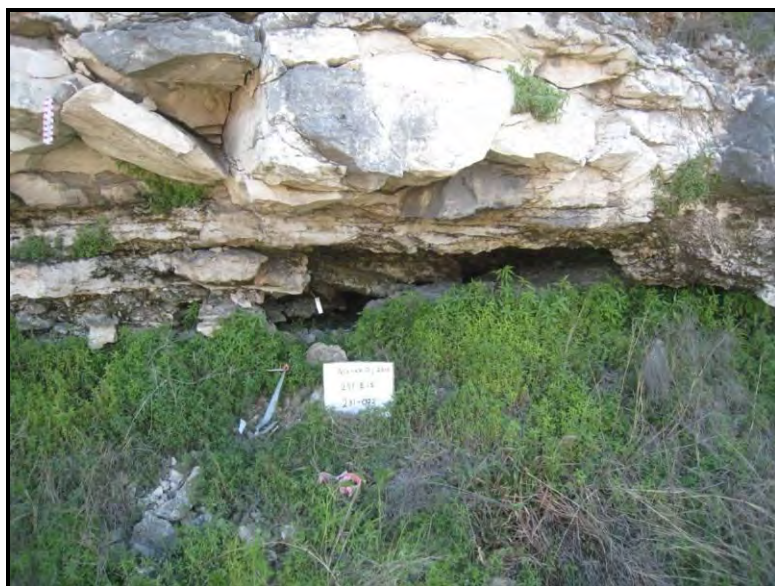
Figure 123. Entrance to Cool Cave prior to excavation.

281-073, Cool Cave This feature is developed in an enlarged bedding plane in the east road cut of US 281. When initially assessed, its entrance was 2 m (6.6 ft) wide and 0.5 m (1.6 ft) high (Figure 123). It extended at least 3 m (9.8 ft) into the road cut, with mesocavernous voids continuing on. It was excavated on 15-16 June 2010. Three m³ (106 ft³) of material was removed utilizing 20 person-hours of labor with hand and power tools (Figure 124). This resulted in enlargement of the entrance to 1 m (3.3 ft) in height, and enabled access to the full 10 m (32.8 ft) length of the cave (Figure 125). It was named for the cool temperature inside relative to the outside summer heat. The cave begins as a dirt-floored crawl, and widens out to 3.5 m (11.5 ft) across. At this point there is a shallow pit on the north side of the passage with a damp bedrock floor. The back portion of the cave gets very low. The post-excavation dimensions of this feature were 10 m (32.8 ft) long by 1 m (3.3 ft) wide by 1.2 m (3.9 ft) deep.

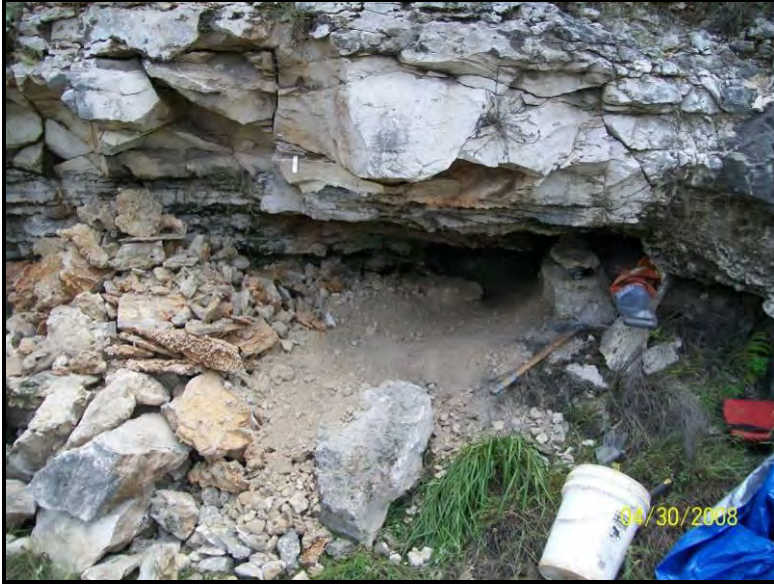
Figure 124. Entrance to Cool Cave after excavation.

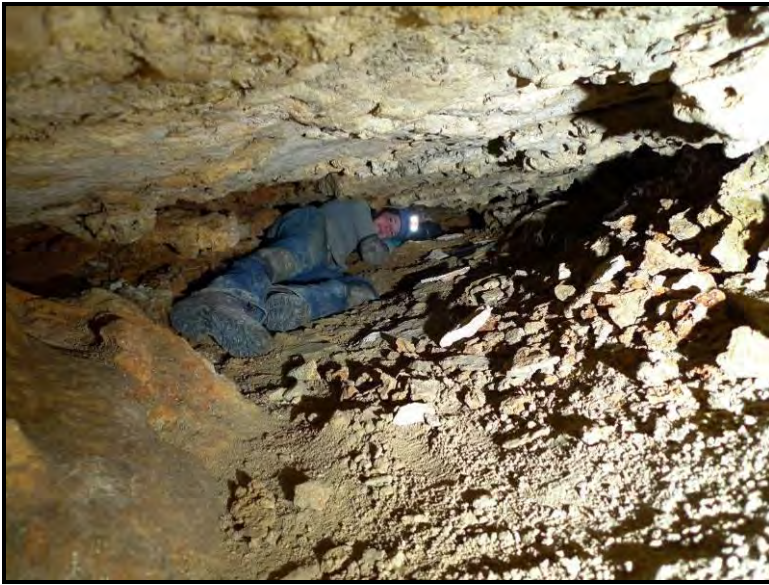
Figure 125. Interior of Cool Cave after excavation.

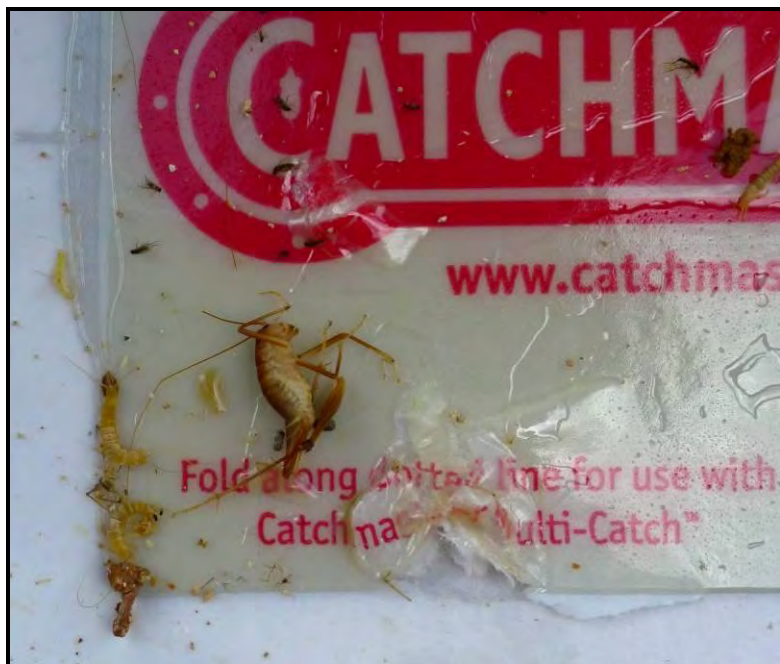
Figure 126. Glue trap retrieved from Cool Cave containing *Texoreddellia* subterranean silverfish and *Ceuthophilus cunicularis* cave crickets.

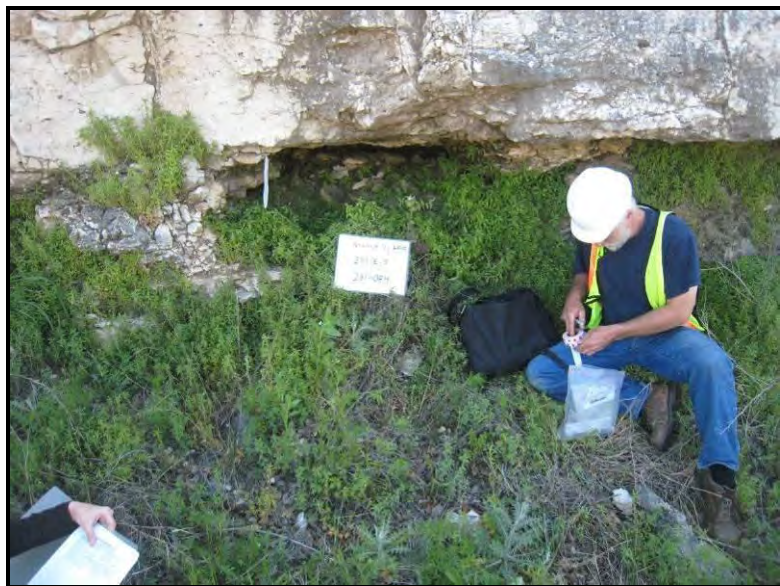
281-074, solution cavity/enlarged bedding plane This enlarged bedding plane opening is in the road cut on the east side of US 281 (Figure 127). It is 1 m (3.3 ft) wide, 0.3 m (1 ft) tall, and extends into the road cut for 1 m (3.3 ft) (Figure 128). This feature was not recommended for excavation (Table 1).

Figure 127. Overview of feature 281-074.

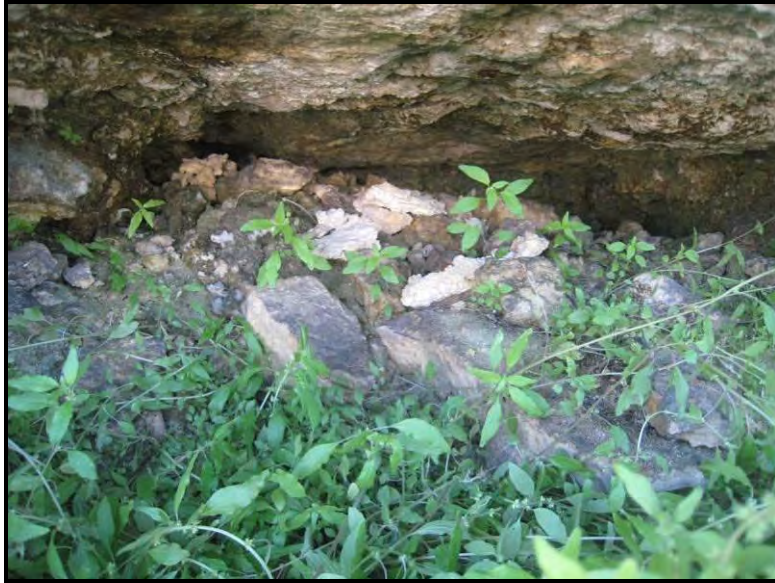
Figure 128. Interior of feature 281-074.

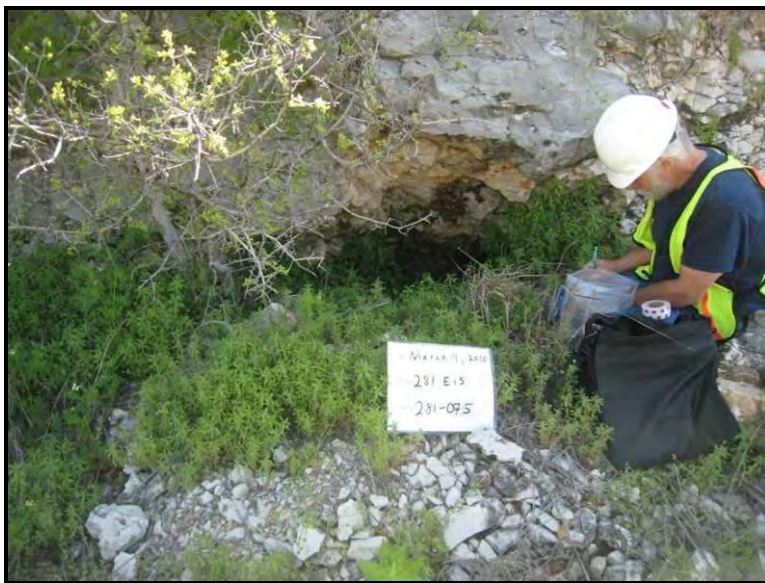
Figure 129. Overview of feature 281-075.

281-075, solution cavity/enlarged bedding plane This feature is an enlarged bedding plane developed in the east road cut of US 281. When initially assessed it was 1 m (3.3 ft) wide, 0.4 m (1.3 ft) tall, and extended into the road cut for 1.5 m (4.9 ft) (Figure 129). It contained black, modern soil, rocks, and leaf litter. This feature receives channelized flow from the highway bar ditch. The troglophile meshweaver spider *Cicurina varians* was found in this feature. Excavation was conducted on 15 June 2010. Eight person hours of effort utilizing hand tools resulted in the removal of 1 m³ (35 ft³) of material. This resulted in the enlargement of the entrance to 1.5 m (4.9 ft) in diameter, and the floor was lowered to 1 m (3.3 ft) below the elevation of the bar ditch for a total depth of 2 m (6.6 ft). The floor was composed of clay that extended up the walls to meet the bedrock ceiling, with no voids visible (Figure 130).
